SUBJECT Miscellaneous Information on
Latvian Ports (piers and wharfs,

PROCESSING COPYwarehouses, hydrographic data,
and port security.

1. Ventspils
2. Riga
3. Ventspils (two sketches included)
4. Ventspils (port plan included)
5. Riga

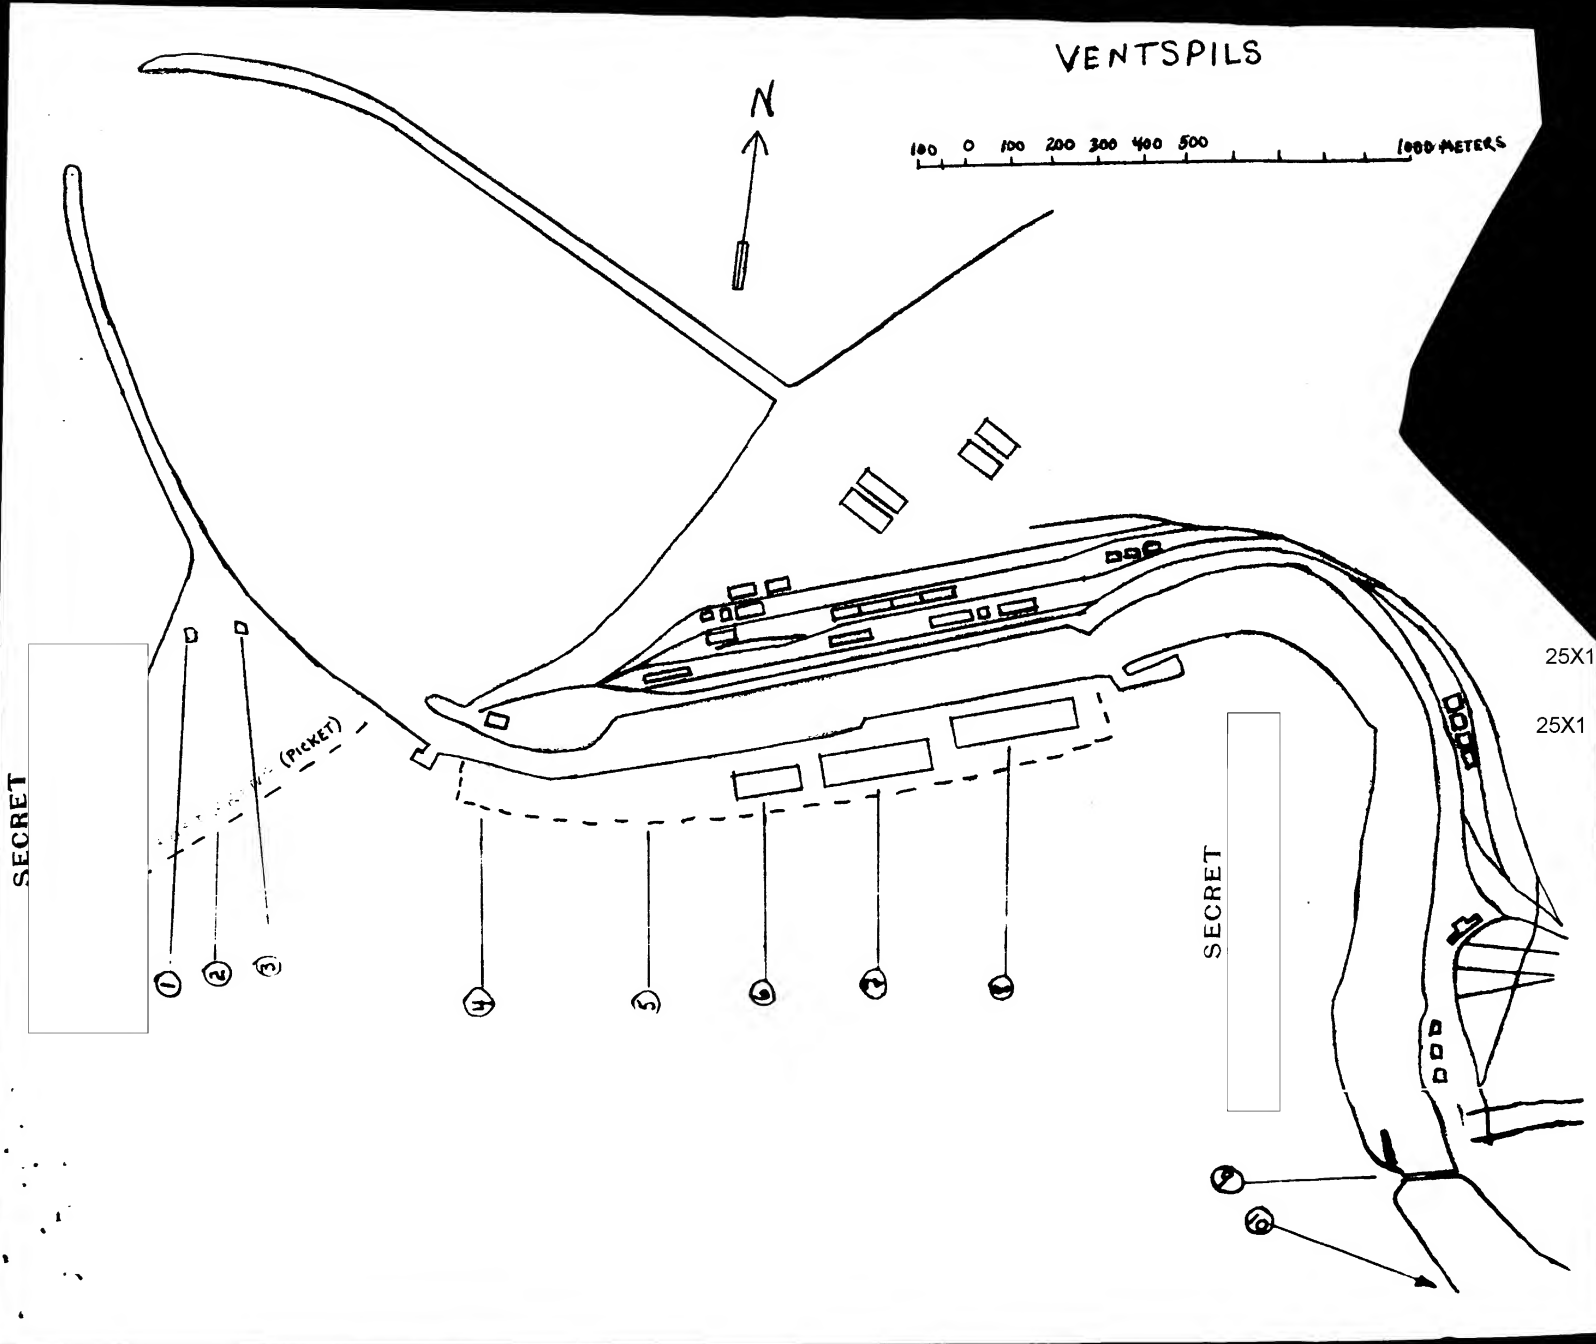
Ventspils Harbor. Technical Legend

3. At the southern pier abutment is a radar similar to one type Gage. Three soldiers guard the area but the territory is not closed off. One-two kilometers south of the southern pier abutment is a stretch of beach area three kilometers in length which is open to the local population.

5. Within the area of the base there are stored sweep equipment and buoys and beacons (prickar). In one other storehouse there were ammunition supplies. The repair workshop can only perform small jobs. Damaged ship bottoms cannot be repaired in the port. Modern salvage vessels with diving equipment and rescue stations are at the base.

1. Radar similar to the Gage type
2. Picket for guarding of the pier area
3. Signal station
4. Barbed wire fence for naval base
5. Entrance with guard
6. Sweep equipment and buoys
7. Ammunition stores
8. Workshops
9. Wooden bridge which is only permitted to be travelled over by a vehicle (cart?) under control
10. Railway bridge
